DEPARTMENT OF TRANSPORTATION

Contract #: 04-0120F4Cty: SF/ALA Rte: 80 PM: 13.2/13.9File #: 69.28**WELDING INSPECTION REPORT****Resident Engineer:** Siegenthaler, Peter**Address:** 333 Burma Road**City:** Oakland, CA 94607**Report No:** WIR-018106**Date Inspected:** 09-Nov-2010**Project Name:** SAS Superstructure**OSM Arrival Time:** 700**Prime Contractor:** American Bridge/Fluor Enterprises, a JV**OSM Departure Time:** 1900**Contractor:** Zhenhua Port Machinery Company, Ltd (ZPMC), Changxing Island **Location:** Shanghai, China**CWI Name:** Zhu Feng**CWI Present:** Yes No**Inspected CWI report:** Yes No N/A**Rod Oven in Use:** Yes No N/A**Electrode to specification:** Yes No N/A**Weld Procedures Followed:** Yes No N/A**Qualified Welders:** Yes No N/A**Verified Joint Fit-up:** Yes No N/A**Approved Drawings:** Yes No N/A**Approved WPS:** Yes No N/A**Delayed / Cancelled:** Yes No N/A**Bridge No:** 34-0006**Component:** TOWER Components**Summary of Items Observed:**

WELDING INSPECTION REPORT

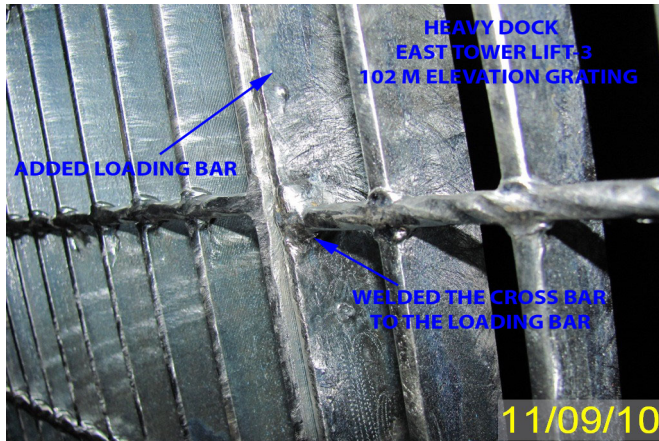
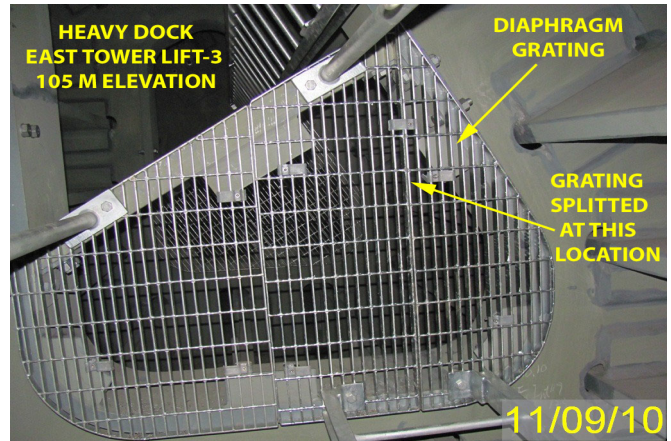
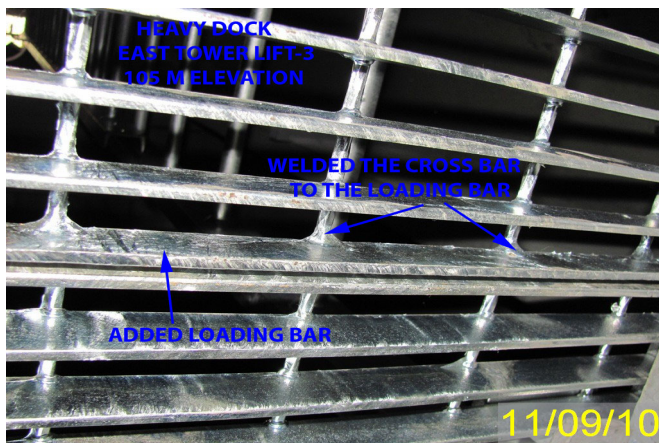
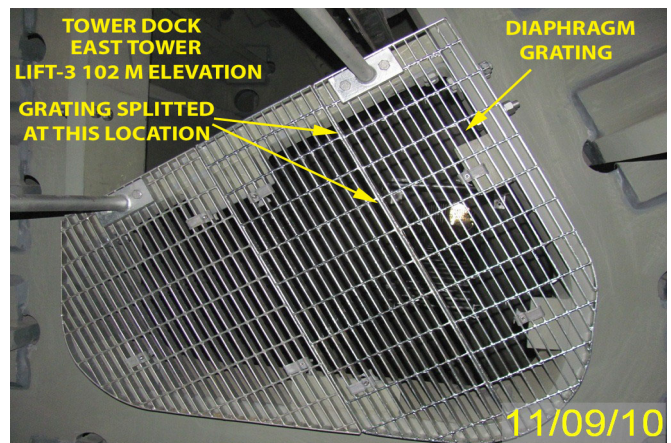
For further information see the attached pictures of East tower lift-3 (Typical).

This QA inspector performed VT for diaphragm gratings at elevations 102 M and 105 M on North, East, West and South shafts of lift-3 after ZPMC personnel completed the repair work as per the RFI-ZPM-00891R00. This area was previously tested and accepted by ZPMC/ABF Quality Control personnel. The member is identified as TOWER Component.
